# **INDOOR AIR QUALITY ASSESSMENT**

**Veterans Memorial High School  
485 Lowell Street  
Peabody, Massachusetts**

Prepared by:  
Massachusetts Department of Public Health  
Bureau of Environmental Health Assessment  
April, 2002

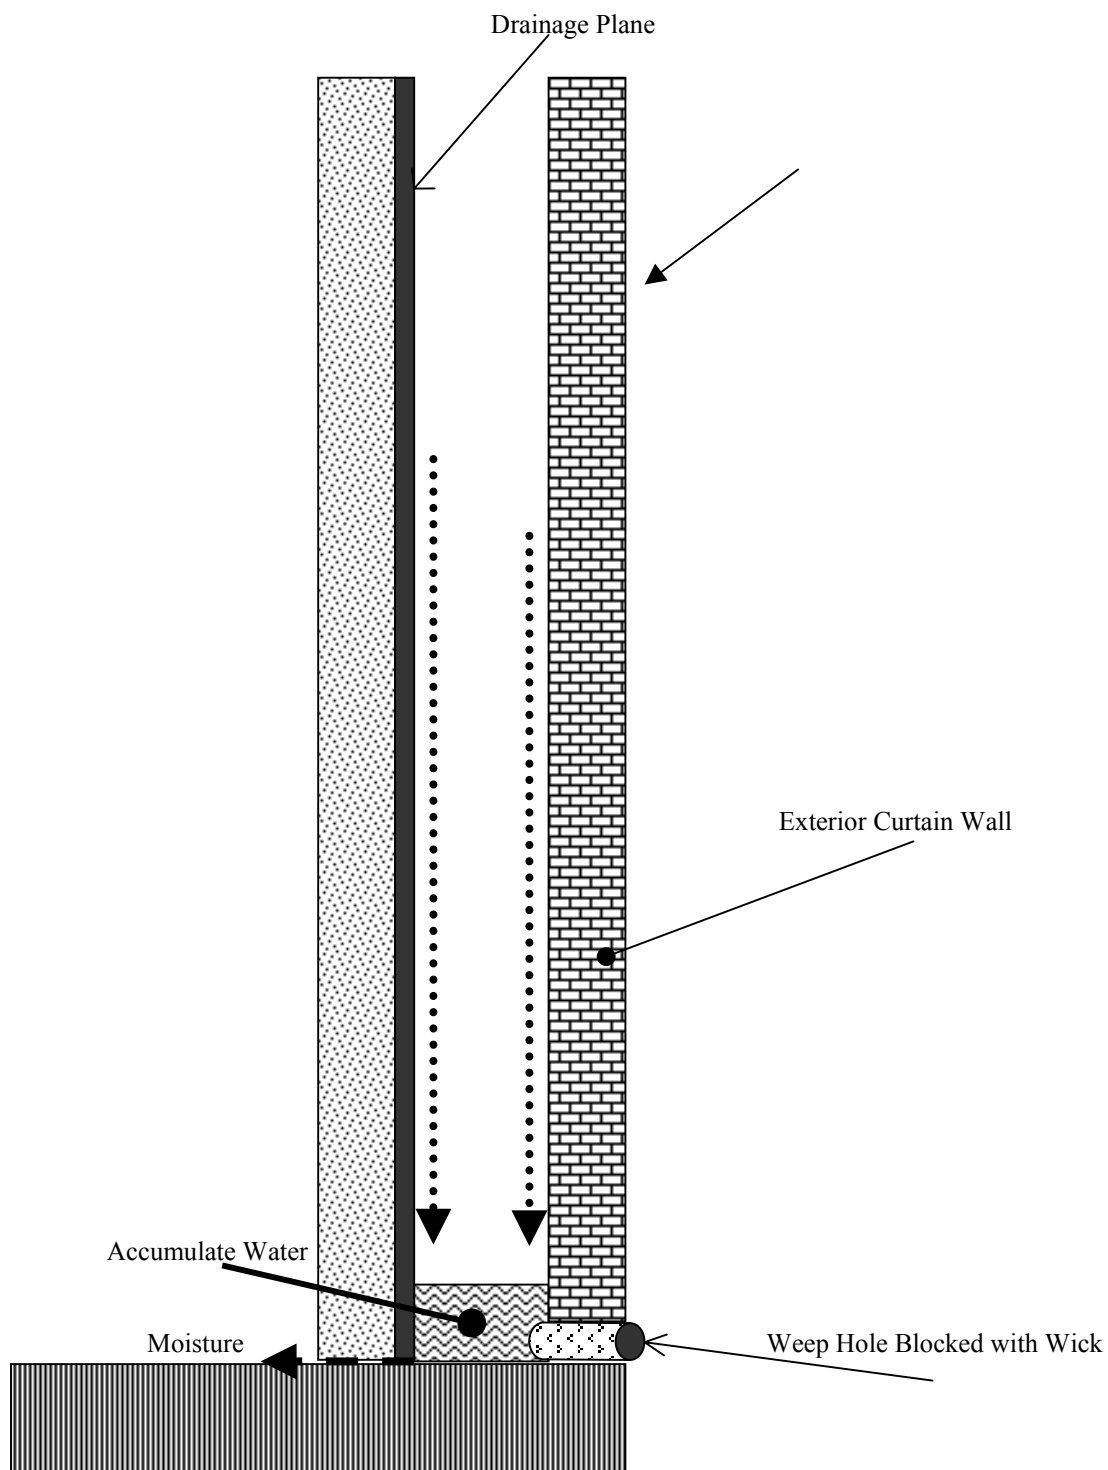
**Figure 4**  
**Weep Hole Blocked with Wick and Water Accumulation in the Drainage Plane**

An extensive examination of the exterior brick walls of PVMHS was conducted to identify the location and condition of weep holes. Weep holes were found approximately three feet above the ground, located on the north and east facing exterior walls (see Picture 8). Of note is that each weep hole was blocked with a wick material (see Picture 9). Most weep holes in these walls have wicks installed. Wicks were originally installed to enhance water movement from the drainage plane. Over time, sediment accumulation turns the wick into a stopper, which prevents water drainage from the exterior wall

system. It is not recommended to “use ropes or tubes for weep[hole]s” (Nelson, P.E., 1999).

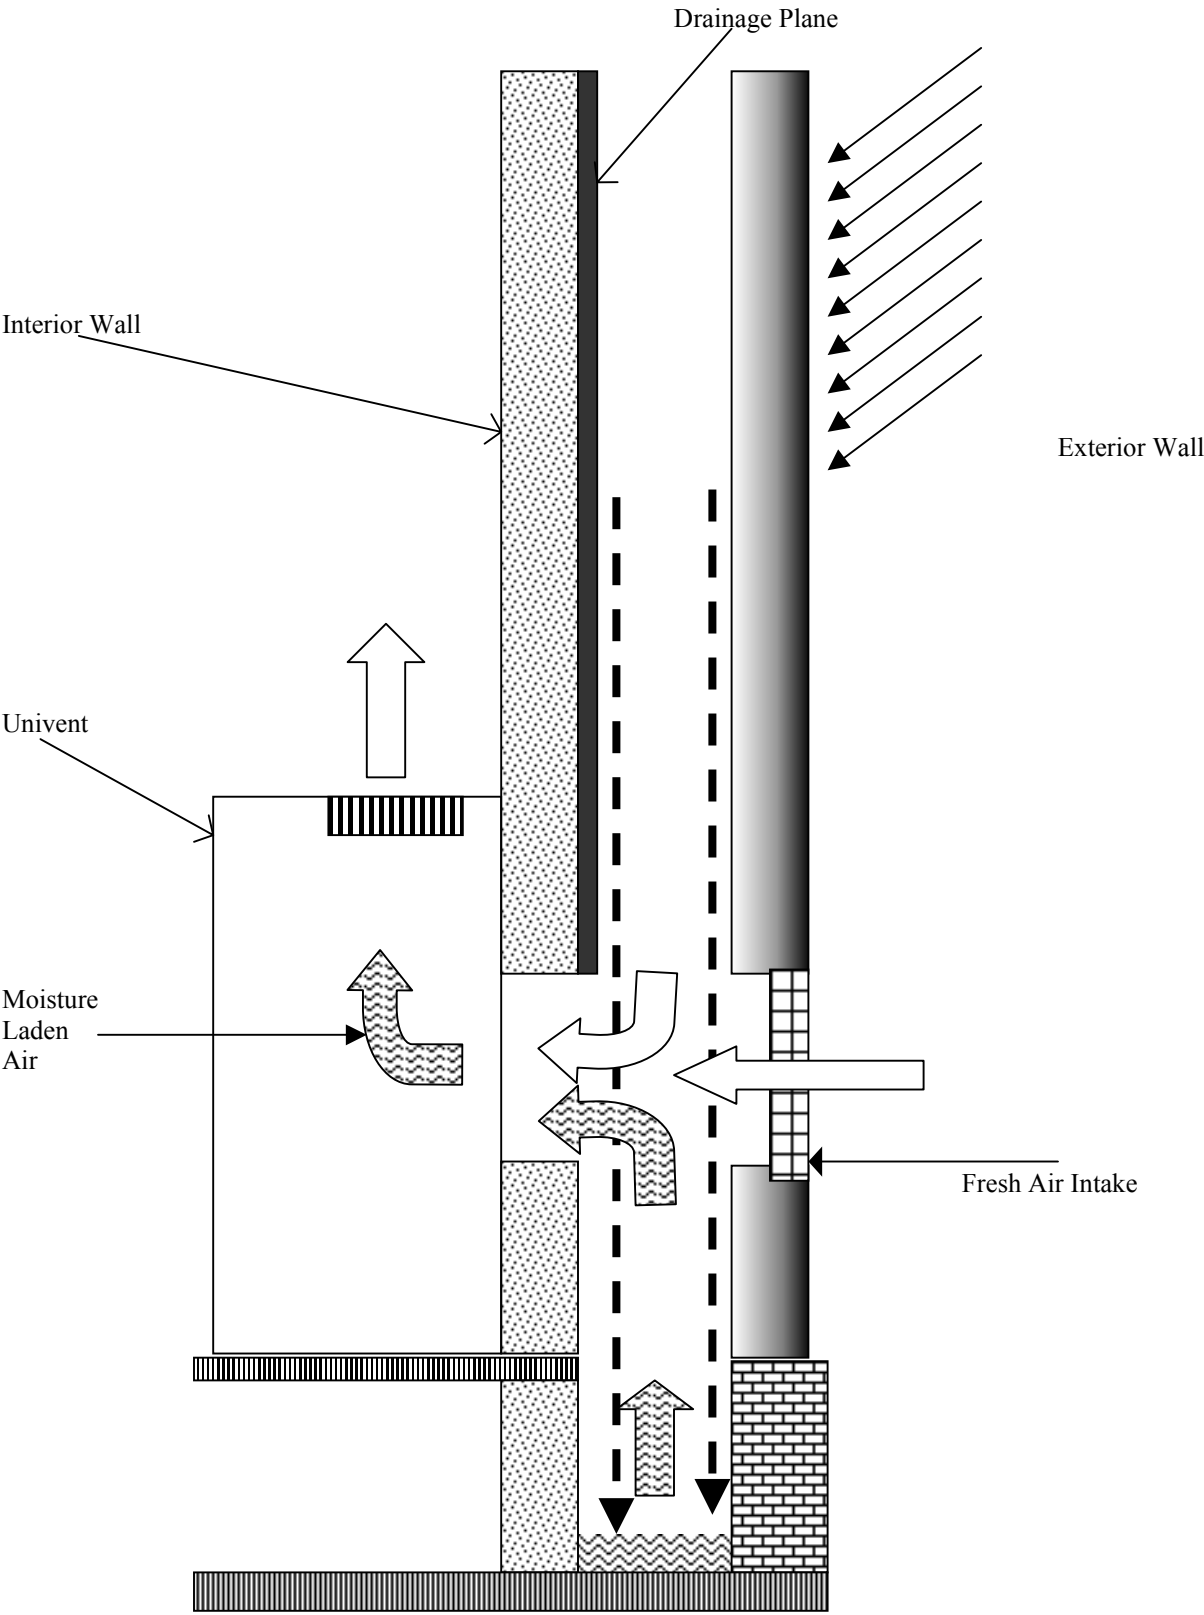
**Figure 5**  
**Draw of Moisture From Wall System Into Univent Fresh Air Intake Vent**

In order to ascertain the condition of the exterior wall system, the fresh air intake grill should be removed from several univents to check for the presence of a sheet metal duct connecting the grill to the univent. If no such duct exists, air may be drawn from the drainage plane by univents. Under certain circumstances, materials accumulated in the

wall drainage plane (e.g., water vapor and microbial growth) may be drawn into univents and dispersed indoors (see Figure 5). The presence of water vapor in univents is confirmed by the presence of corrosion on the underside of heating coils in univents on the third floor. Heating coils are made of steel (confirmed by magnetic attraction using the same magnet used on the exterior metallic cladding system), which when exposed to water vapor, will corrode to form iron oxide (rust).

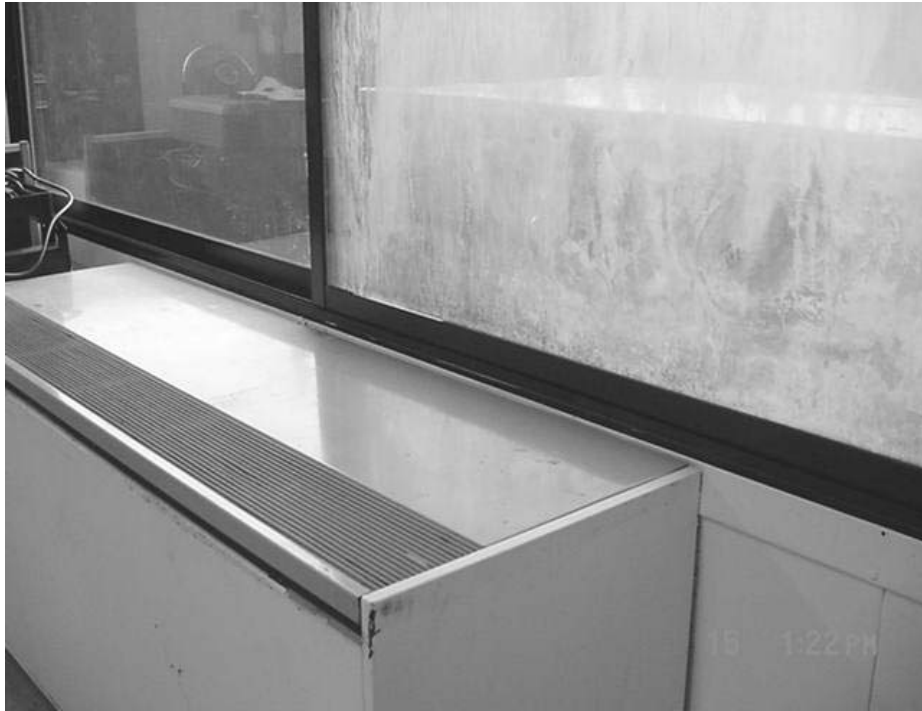
**Picture 2**

**Univent With Original Fresh Air Diffuser Grilles**

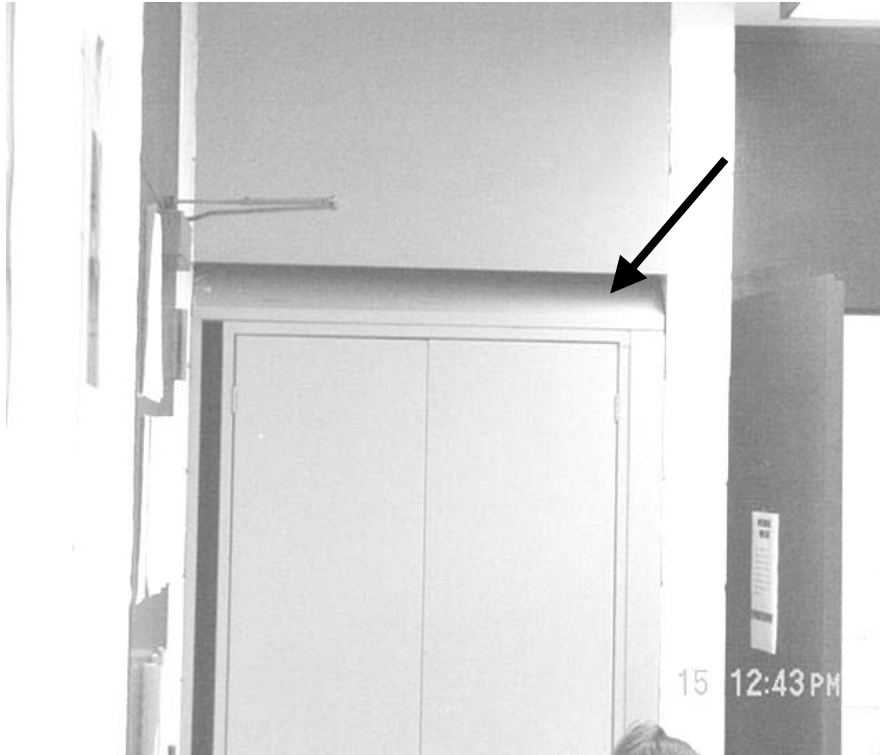
**Picture 3**

**Slotted Exhaust Vents above Classroom Coat Closets**

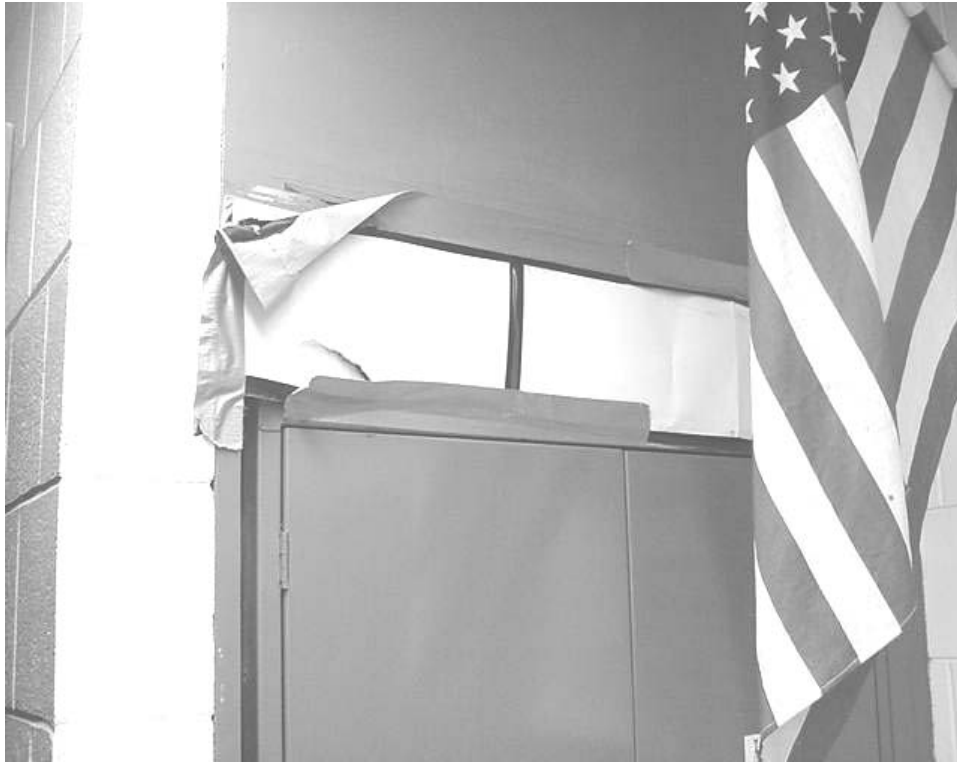
**Picture 4**

**Classroom Exhaust Vent Sealed With Cardboard and Duct Tape**

7. Inspect rooftop exhaust motors and belts for proper function. Repair and replace as necessary.
8. Remove all blockages from univents, air diffusers and exhaust vents to facilitate airflow.

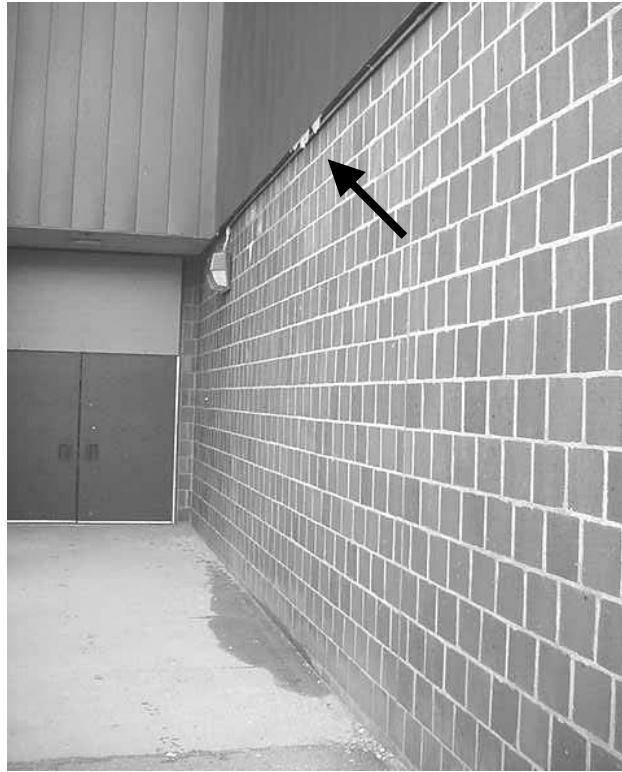
**Picture 5**

**Brick Exterior Wall System of First Floor; Note Ice at the Base of the Steel Exterior Wall System Indicating Water Penetration**

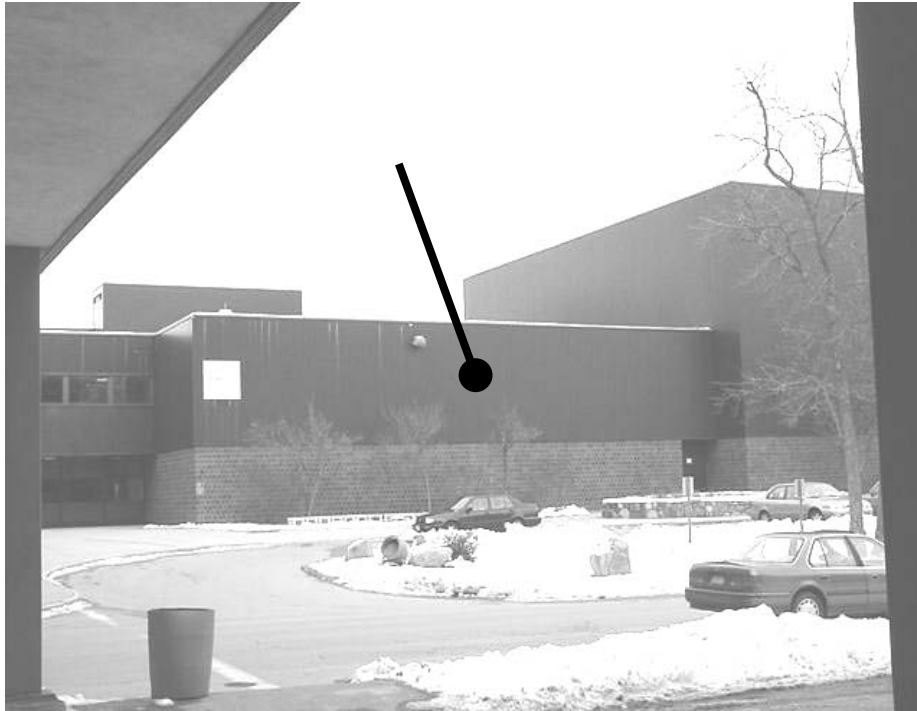
**Picture 6**

**Metallic Cladding System of the Upper Floors That Rests On the First Floor Brick Curtain Wall**

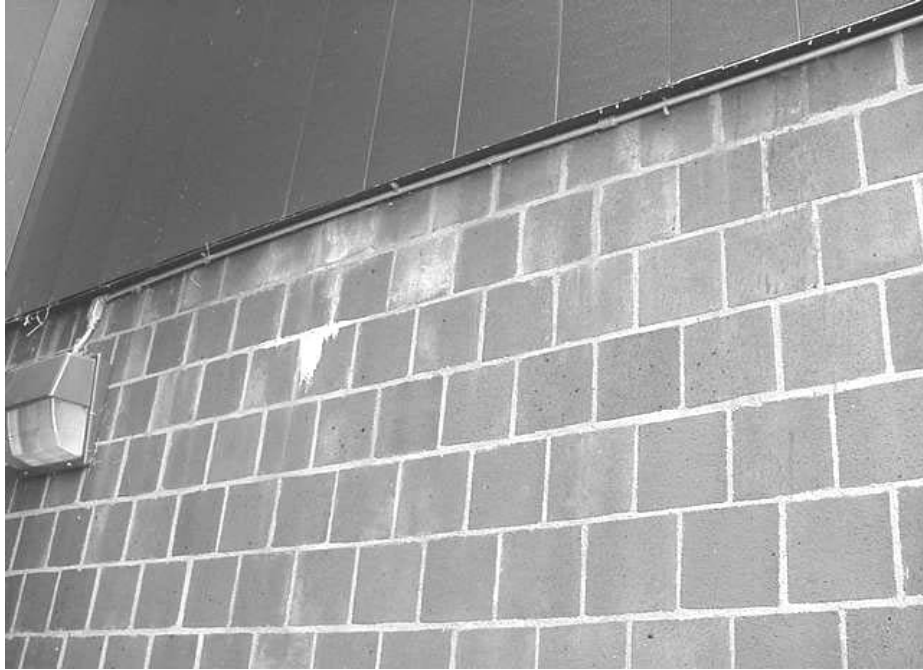
**Picture 7**

**Damage From Water Penetration into the Exterior Brick Wall From  
Steel Exterior Cladding System**

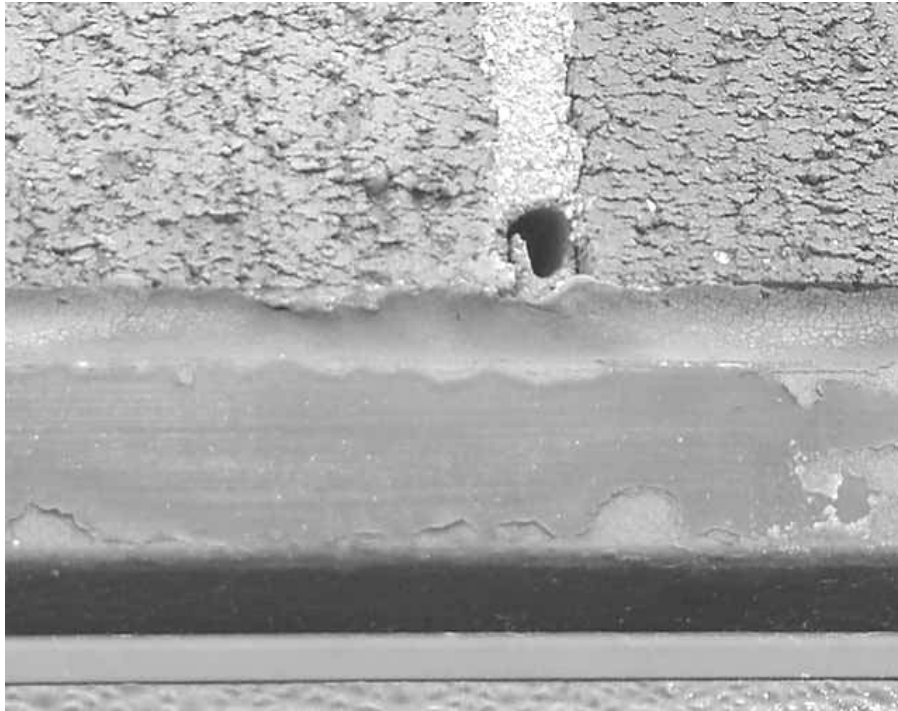
**Picture 8**

**Example of Open Weep Hole; Located on the North and East Facing Exterior Walls**

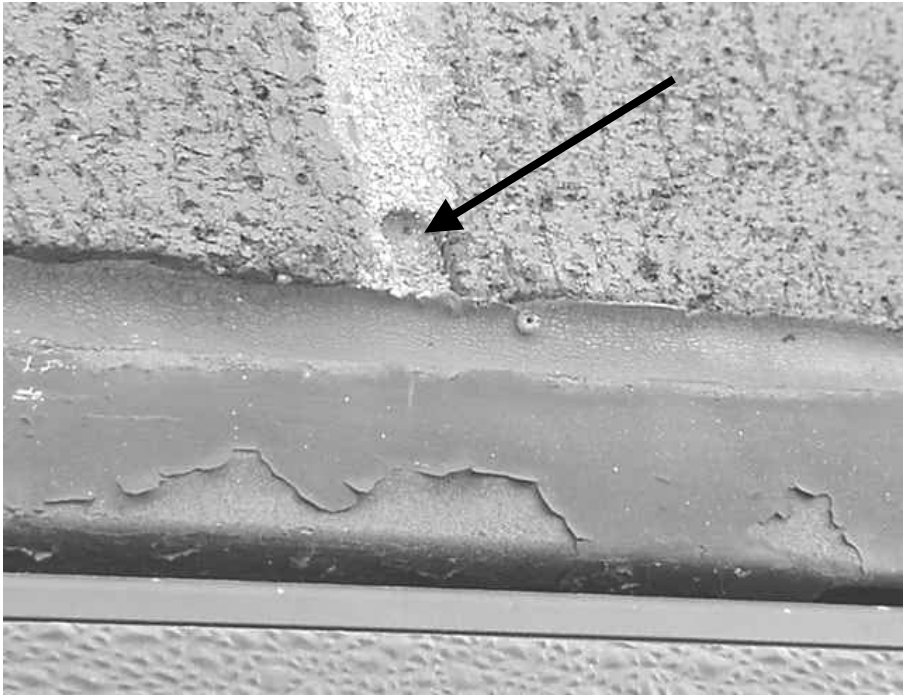
**Picture 9**

**Typically Blocked External Wall Weep Hole**

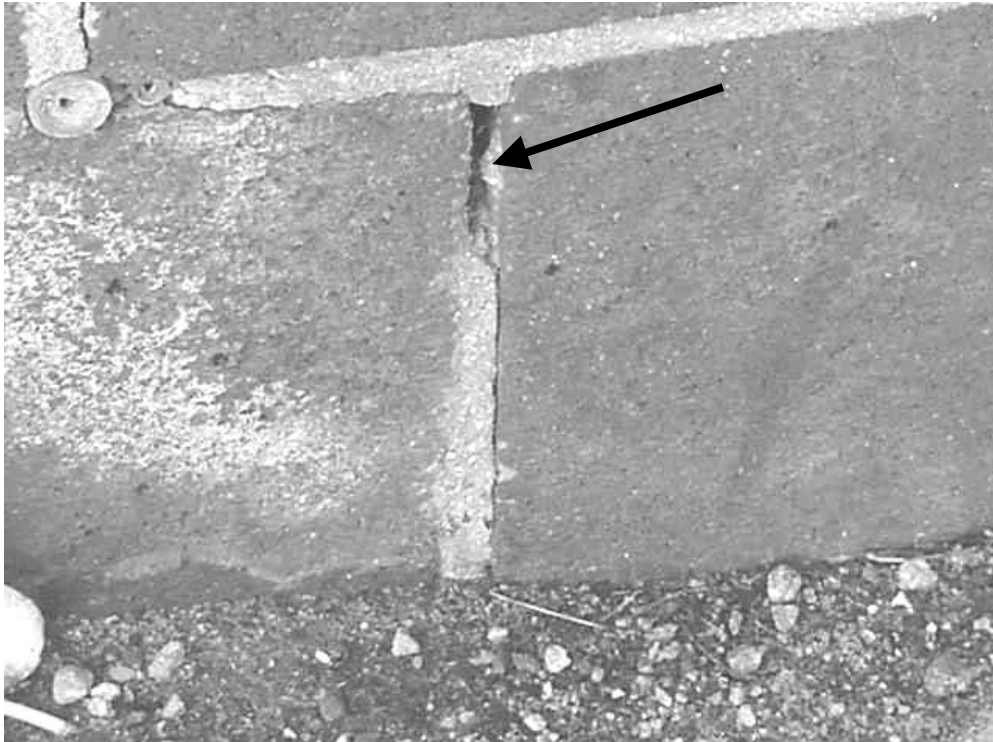
**Picture 10**

**Field House Weep Holes**

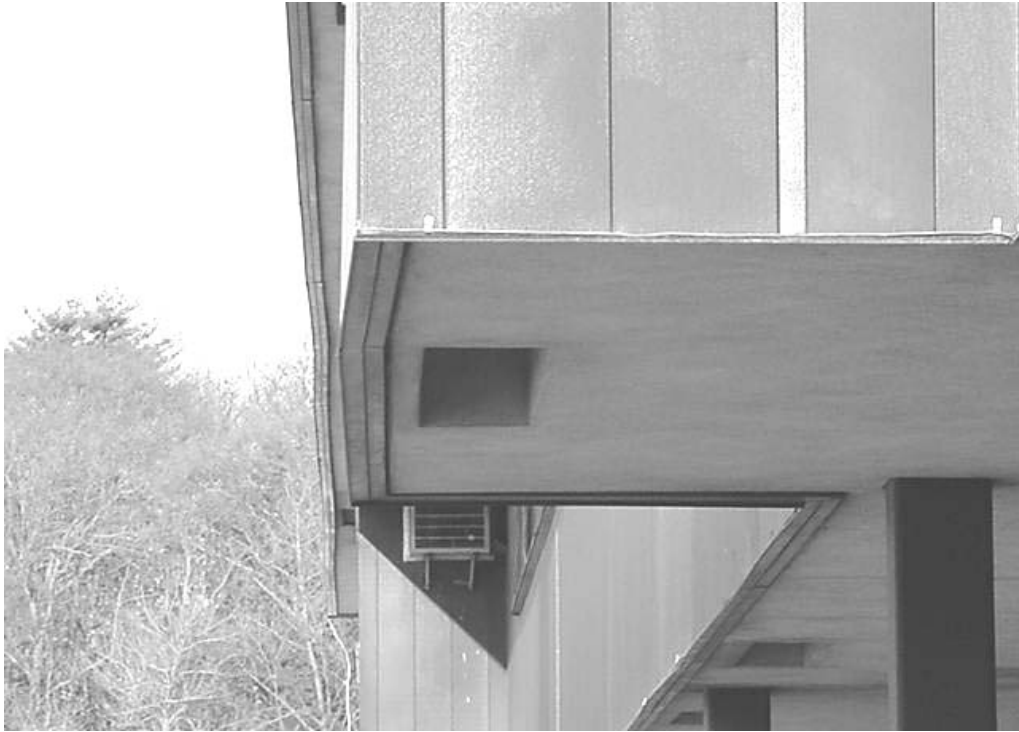
**Picture 11**

**Western Exterior Steel Wall, Which Juts Out From The First Floor Exterior Wall;  
Note Buckling Of Wall System**

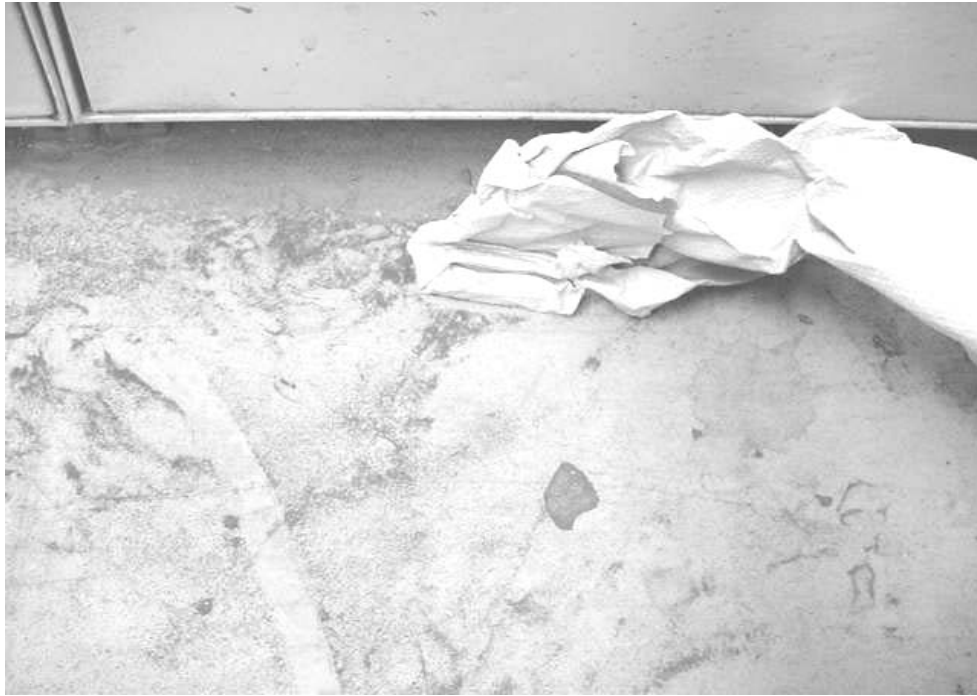
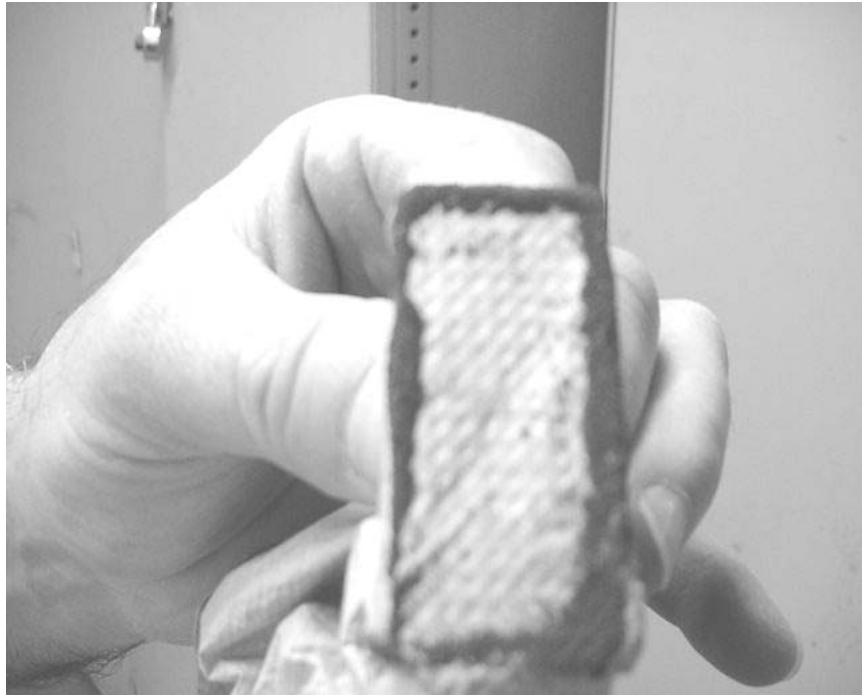
**Picture 12**

Another area that had significant accumulation of iron oxide was the floor of room 243 (see Pictures 12, 12A). This area is served by an air handling unit (AHU) that draws fresh air from the center IC. The floor of the fresh air intake had accumulated water, which appears to enter the duct through a seam in the sheet metal of its floor (see Picture 13). Of note is the wall beneath the fresh air intake for this AHU, which remained moistened for several days after the first day of the current assessment (see Picture 14). This condition may indicate accumulation of water within the exterior wall system. It is believed that the source of iron oxide found on the floor of room 243 was from the heating coil of the AHU connected to this wall.

**Dust On Floor of Room 243 Below Fresh Air Supply Vent**

**Magnet Beneath Paper Holds Dust, Indicating Dust Contains Iron**

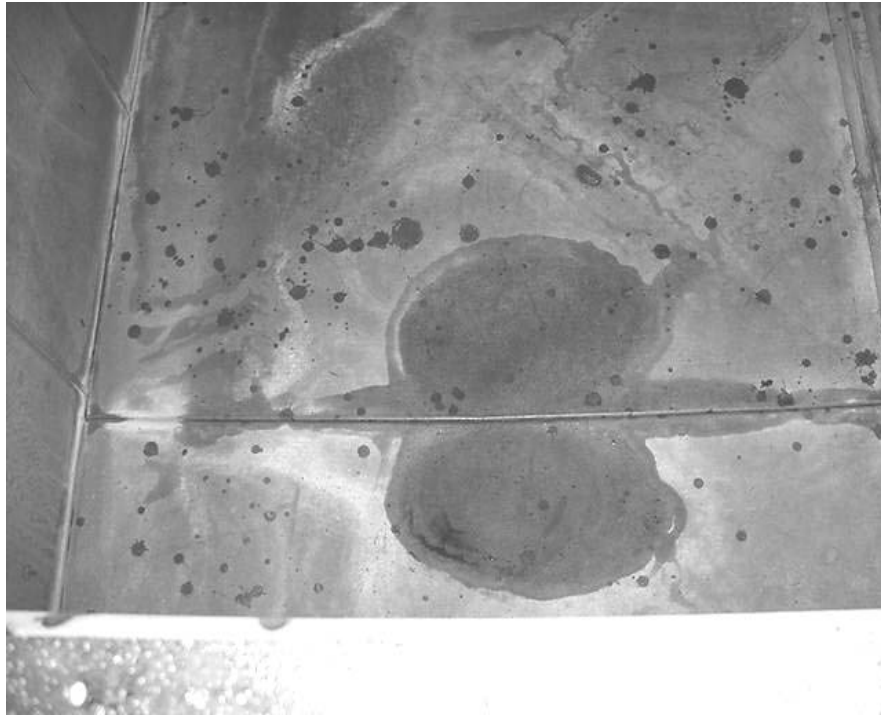
**Picture 13**

**Floor of Air Handling Unit (AHU) That Draws Fresh Air from the Center ICY;  
Note Accumulated Water, Which Appears To Enter the Duct through A Seam in the Floor's Sheet Metal**

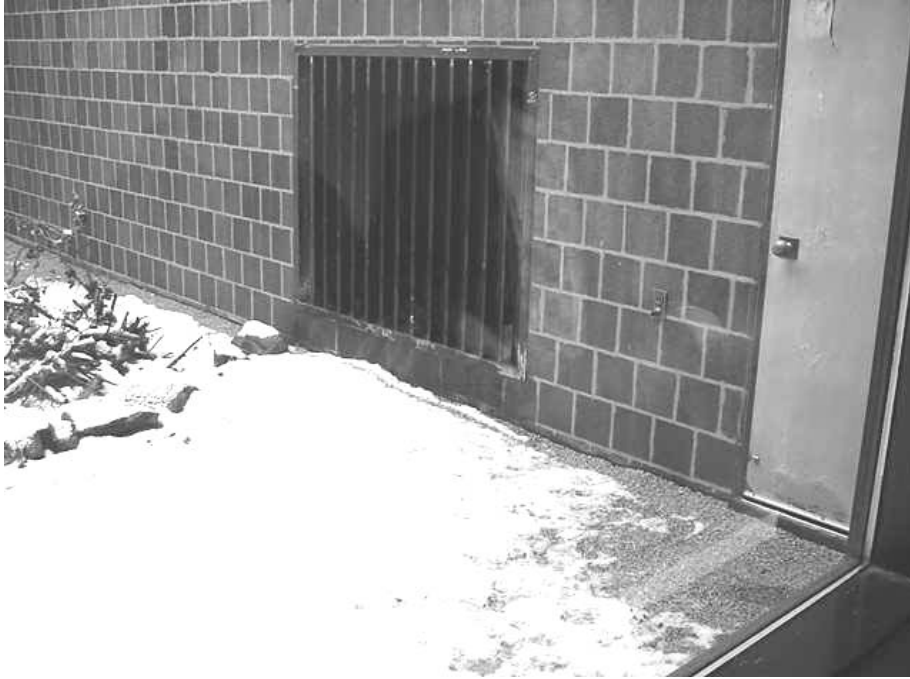
**Picture 14**

**Fresh Air Intake for Duct Depicted in Picture 13; Note Moistened Brick around Center ICY On First Day of Assessment**

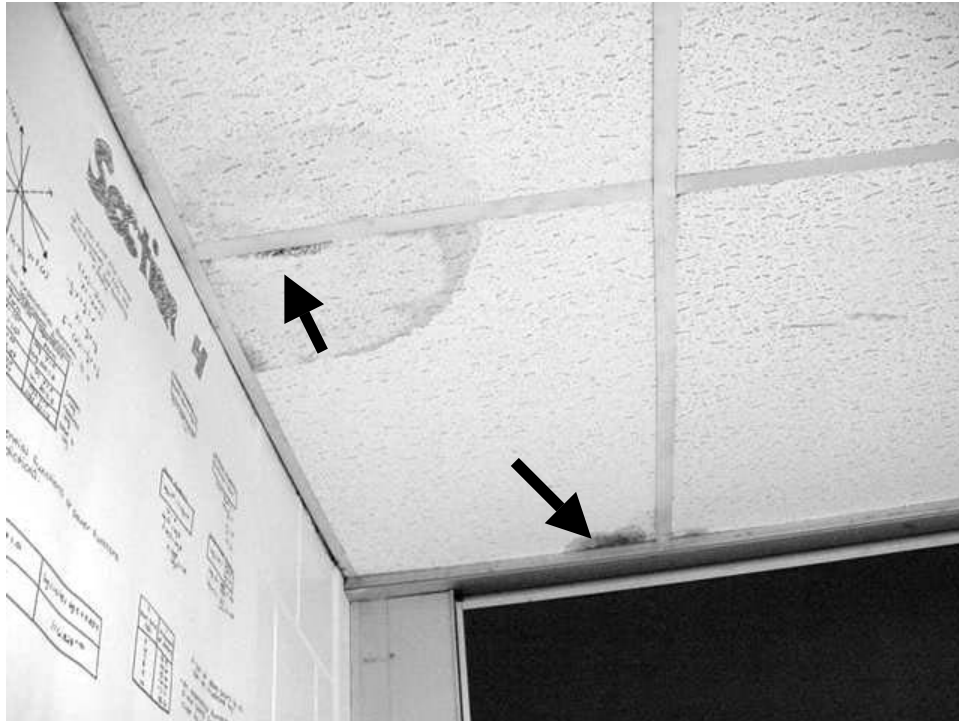
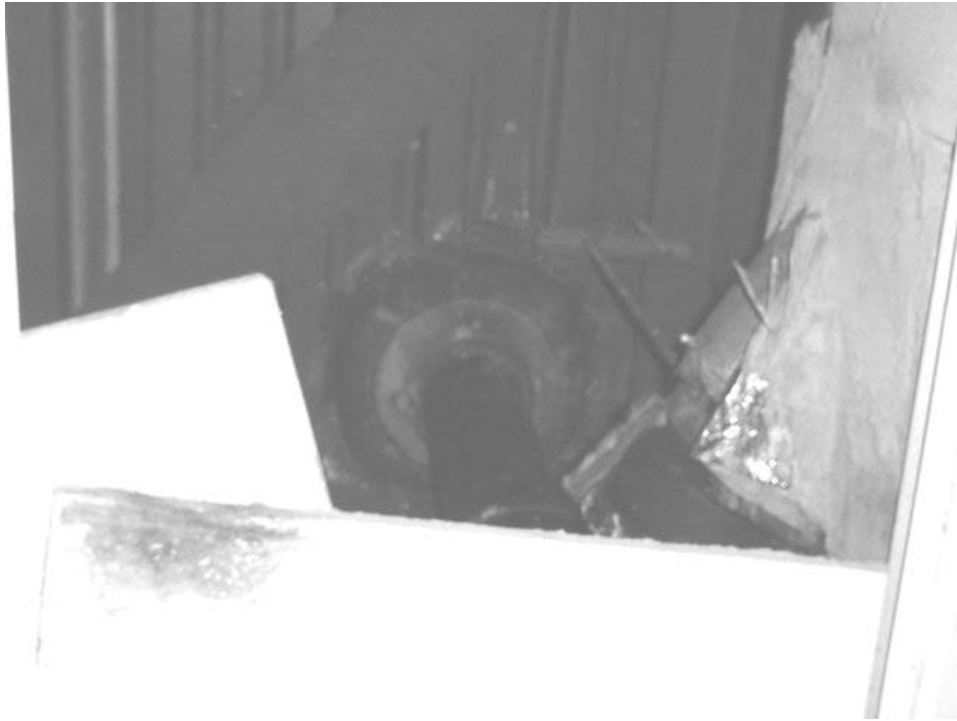
**Picture 15**

A number of classrooms and common areas throughout the building have water-damaged ceiling tiles and other building materials, which indicate leaks from either the roof or plumbing system. Active roof leaks were reported in classroom B-354 as a result of a drain leak. Possible mold growth was identified on a ceiling tile directly below this area (see Pictures 15 & 16).

**Water-Damaged Ceiling Tiles below Roof Drain in Classroom B-354  
Dark Stains Indicate Possible Mold Growth**

**Roof Drain above Ceiling Tiles in Classroom B-354**

12. Report any roof leaks or other signs of water penetration to building maintenance for prompt remediation.
  13. Clean roof drain catches of debris to enhance rainwater drainage. Replace all missing/damaged drain catches to prevent drain clogs. Examine each roof drain for clogs and remove where found. Consider instituting roof inspections on a regular basis to examine catch basins for blockage.

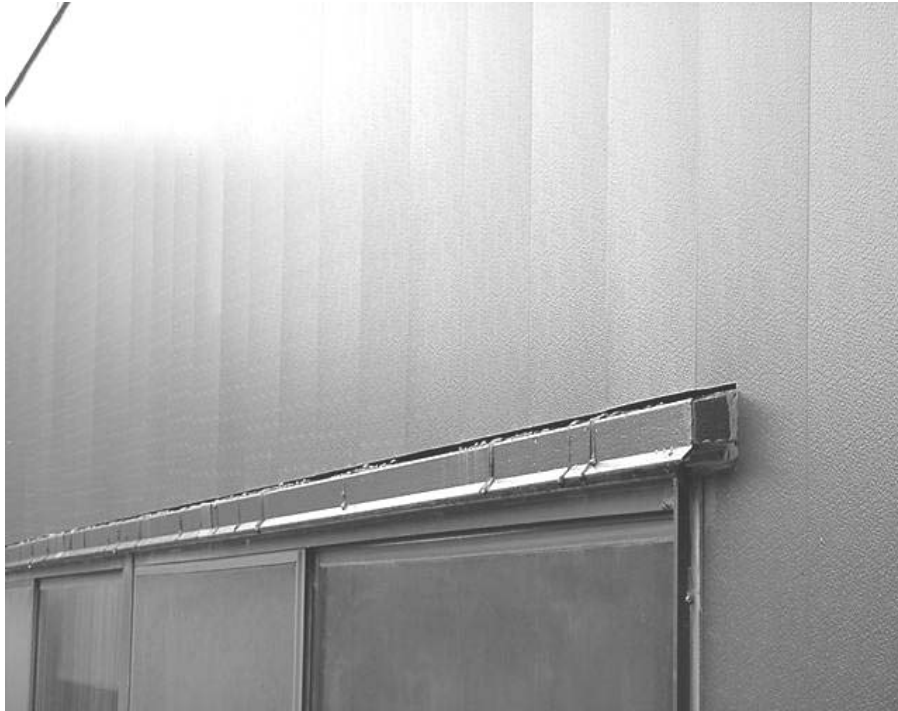
**Picture 17**

Throughout the building, window frame rubber gaskets and caulking around the interior and exterior windowpanes were loose, missing or damaged. In some windows, no gasket system was installed along the top of window frames (see Picture 17). Air infiltration was noted around windows in some areas. Further, some areas had ripped screens and broken windowpanes (see Pictures 18 & 19). Water vapor was observed collecting inside the double-paned windows in many areas (see Pictures 20 & 21). This indicates that window seals are no longer intact. Repairs of window leaks are necessary

to prevent further water penetration. Repeated water damage can result in mold colonization of window frames, curtains and items stored on windowsills.

**No Gasket System Was Installed Along the Top of Window Frames**

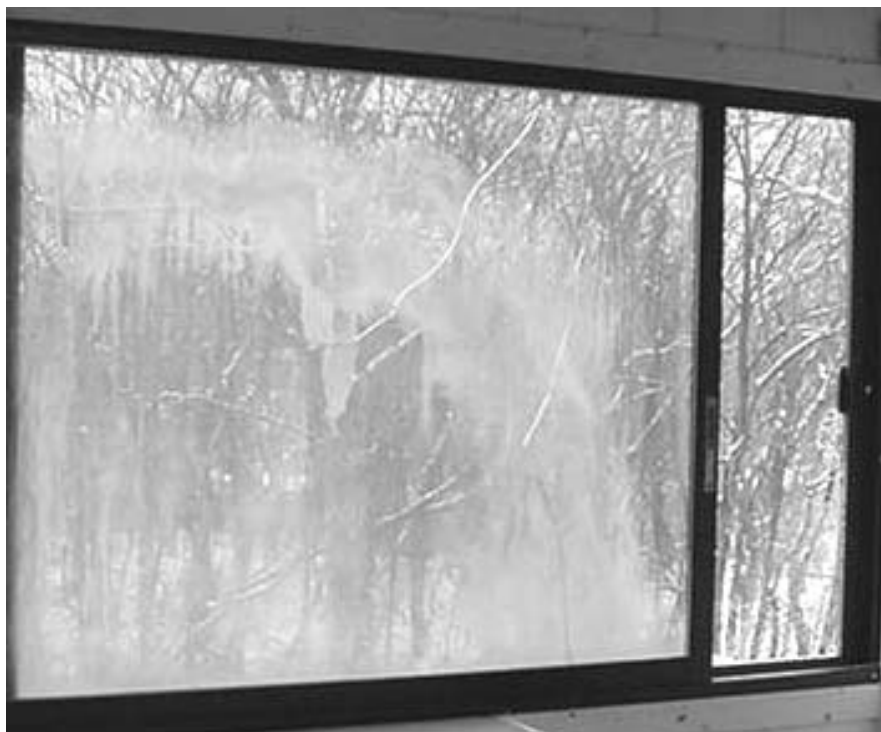
**Picture 18**

**Broken Window Pane in Classroom**

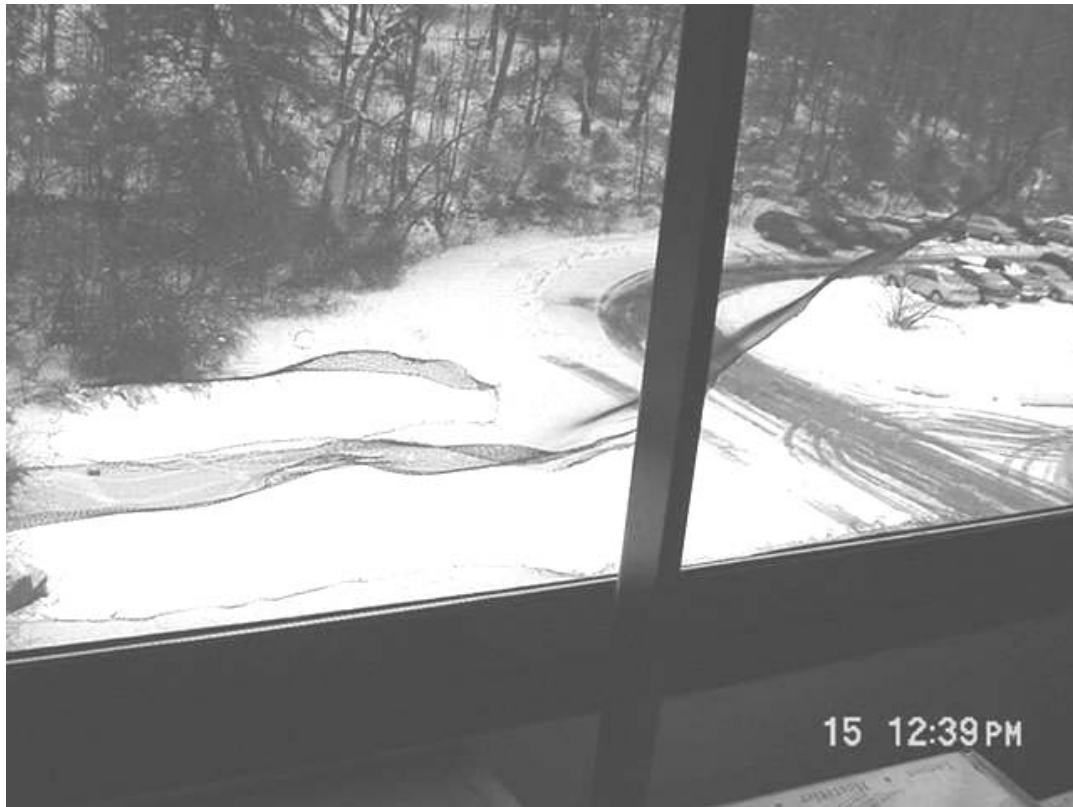
**Picture 19**

**Ripped Window Screens in Classroom**

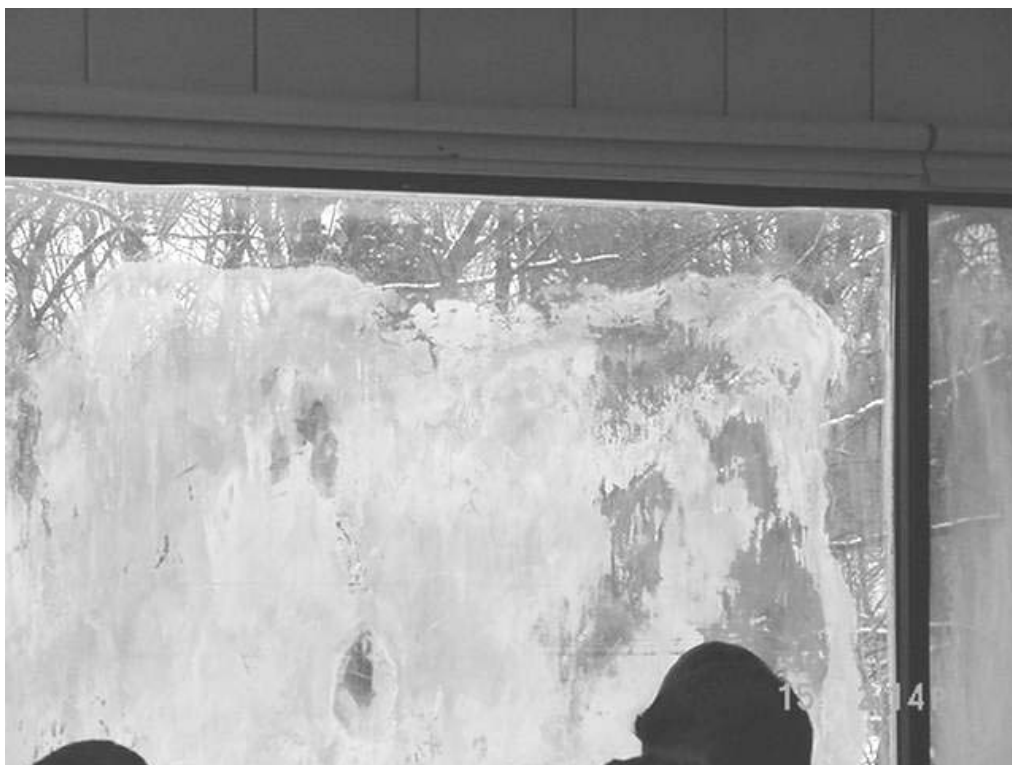
**Picture 20**

**Water-Damaged Windows in Classroom**

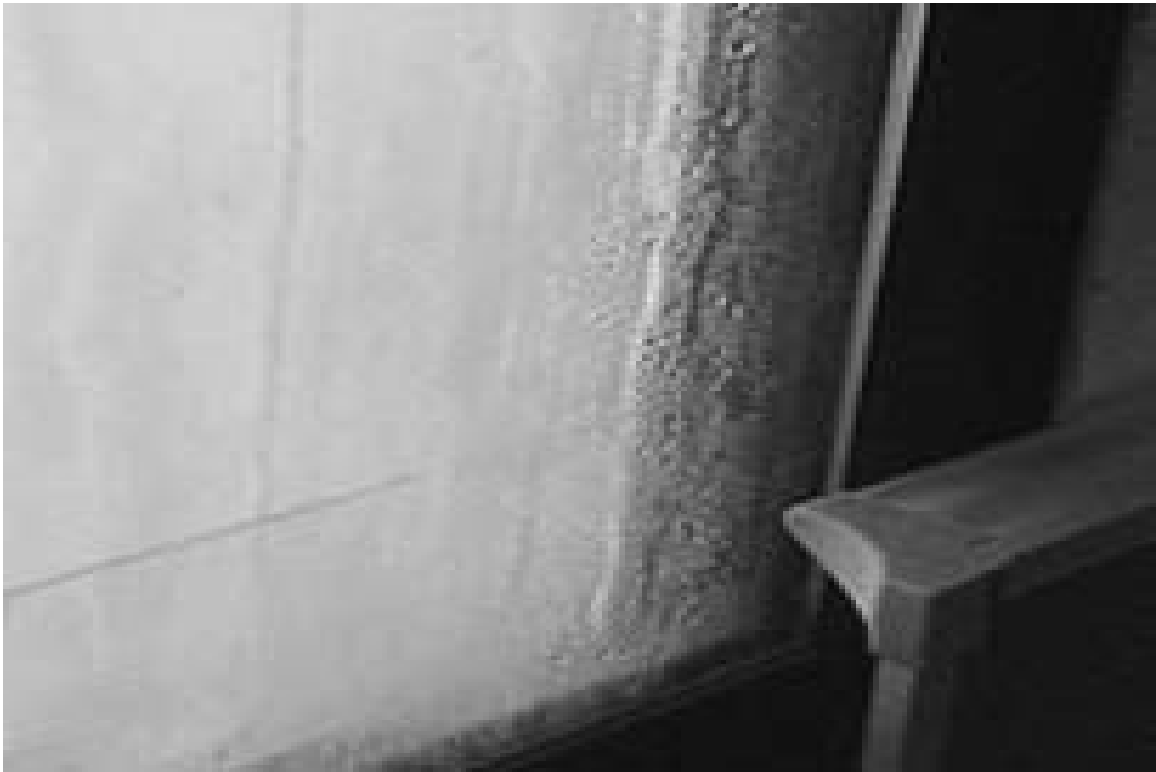
**Picture 21**

**Water Vapor between Window Panes**

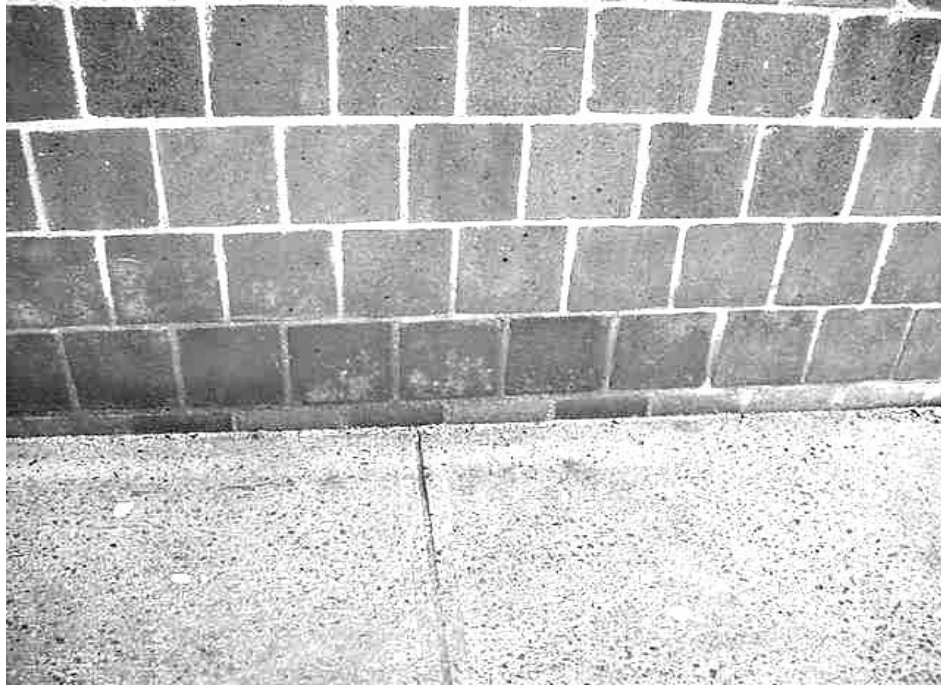
**Picture 22**

Of note is the absence of a complete gutter/downspout system to direct rainwater from the base of the exterior walls (gutters are only installed over exterior doors). After rainstorms, the exterior walls are saturated with moisture. Rainwater runs off the roof onto the ground at the base of the building. This runoff has created a trench parallel to the base of the wall, which allows rainwater and melting snow to pool against the foundation and the exterior walls. Splashing water along the edge of the building wets the base of exterior walls creating a characteristic stain (see Picture 22). Growth of moss on exterior brickwork is another indication of chronic moisture exposure from rainwater. Moss growth also holds moisture against brickwork. North facing corners and walls of the building are particularly vulnerable to moisture for extended periods of time, since this brick is not dried by exposure to direct sunlight. Excessive exposure to water of exterior brickwork can result in damage over time. Also observed was moss growth inside the inner lip of univent air intakes. The design of the fresh air intake allows for accumulation of water and debris, which can in turn be drawn into univents and distributed into occupied areas.

**Splashing Water along the Edge of the Building Wets the Base of Exterior Walls Creating A Characteristic Stain**

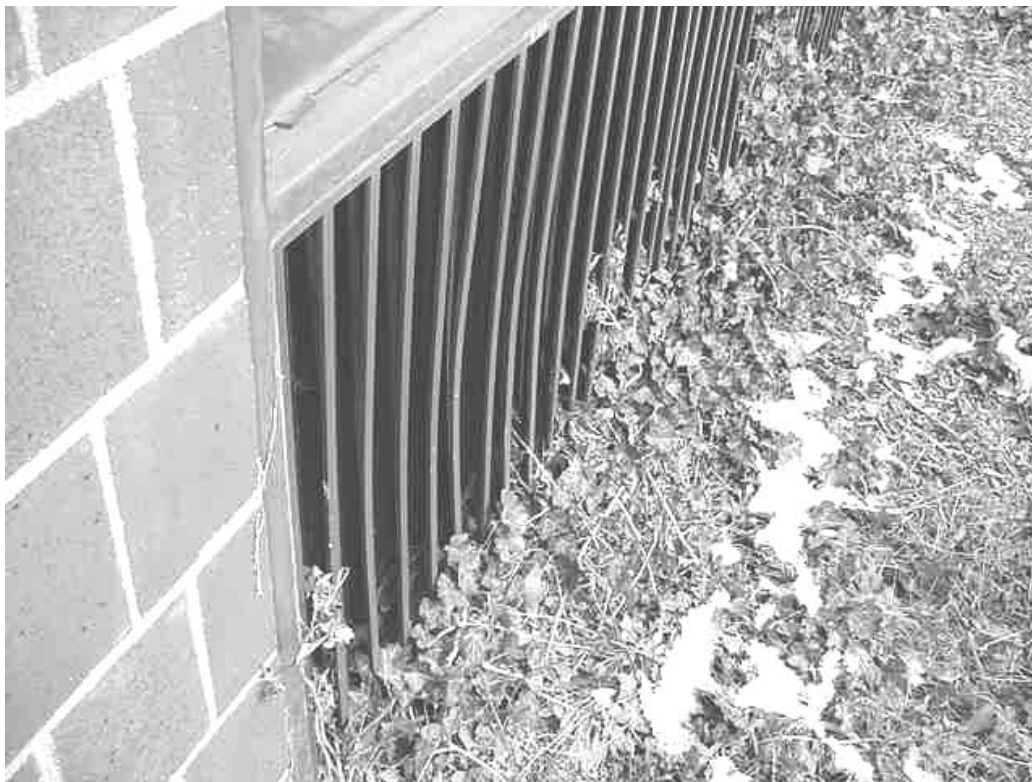
**Picture 23**

Along the perimeter of the building, shrubbery and flowering plants were noted in close proximity to a univent fresh air intake outside of one classroom (see Picture 23).

**Plant Growth In/Around Univent Air Intake**

14. Move plants away from univents in classrooms. Examine drip pans for mold growth and disinfect areas of water leaks with an appropriate antimicrobial where necessary.

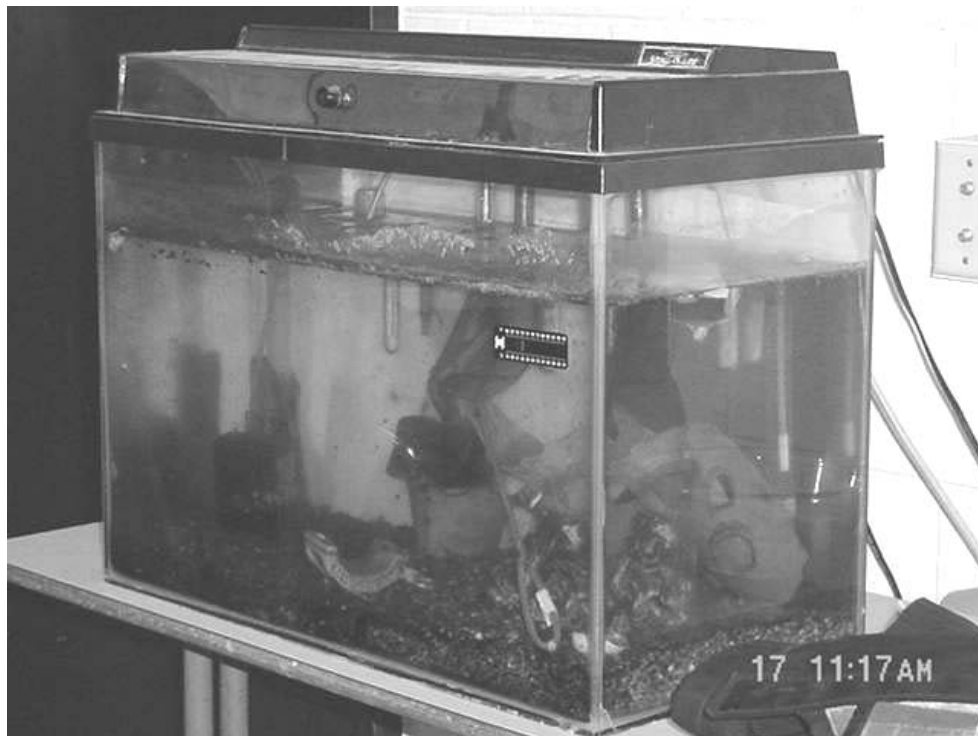
**Picture 24**

**Aquarium with Algae Growth**

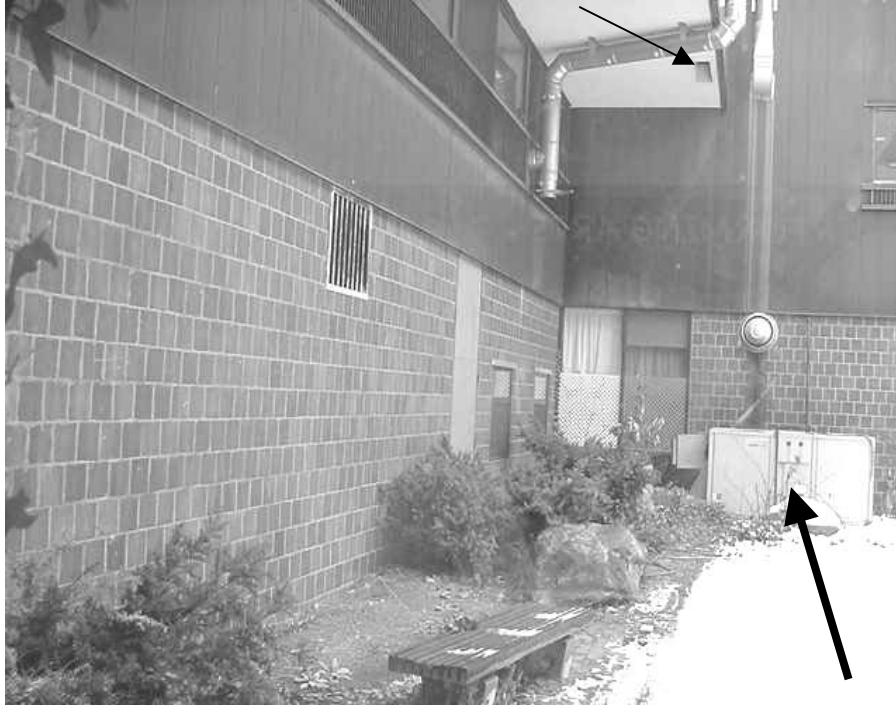
**Picture 25**

A number of other conditions were noted during the assessment, which can affect indoor air quality. The south EC had an AHU installed on the ground that appears to service a kitchen area. During this assessment, this AHU was found to be emitting carbon monoxide from an exhaust port on its side (see Picture 25). This AHU uses natural gas to heat air, which can produce products of combustion, including carbon monoxide. The location of the fresh air intake for this AHU will make it prone to entrain pollutants from plants and soil. Its location will also make its cabinet prone to corrosion from moisture.

**AHU on Floor of South ECY Found to be Emitting Carbon Monoxide from an Exhaust Port;  
Note Fresh Air Intake**
